# Troubleshooting ISDN BRI Layer 3 using the debug isdn q931 Command

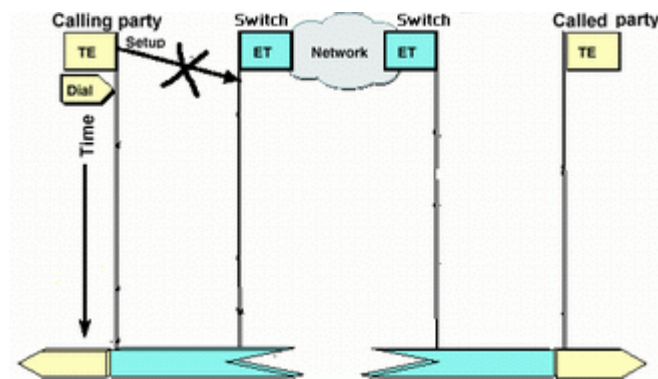
The Calling Router does not send a SETUP message

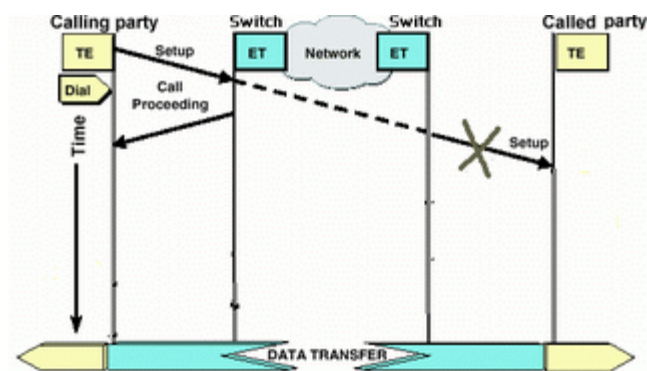
- Verify that the ISDN Switchtype is correctly configured.
- Verify that the ISDN Layers 1 and 2 on the Called Router are functioning.
- Check that the SPID Local Directory

Number (LDN) is correctly configured.

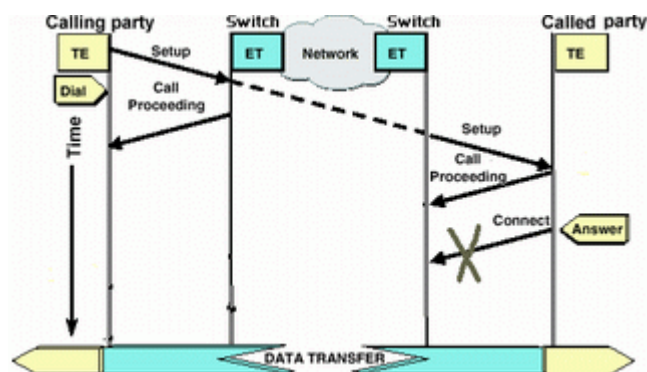
- Check if the call is rejected due to Caller ID or Digital Number Identification Service(DNIS) based screening.
- Verify that the service profile identifier (SPID)s are correct.
- Ensure that there are available B-channels on the circuit that was dialed.
- If multiple BRIs are available, have the telco configure them in a hunt group.
- Check whether you are encountering bearer capability related issues.
- Interpret the disconnect cause code sent (from the Called Router to the Calling Router) in the [DISCONNECT](#) or [RELEASE](#) message.

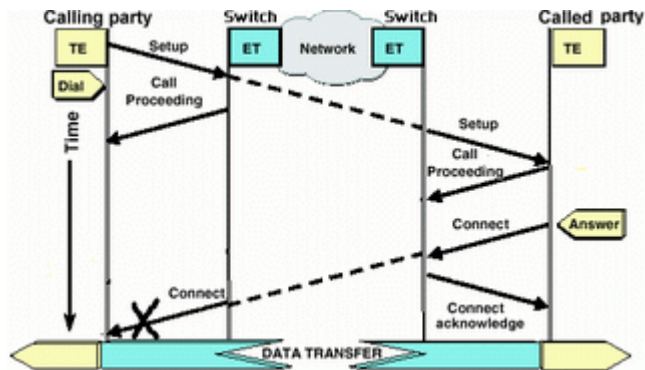
The Called Routers sends a CONNECT message but the Calling Router does not receive it

- Determine whether the router receives a CONNECT\_ACK from the local ISDN switch
